**Automatic Transmission - Fluid Leak**  
**TRANSMISSION & CLUTCH**  
TC003-00

October 20, 2000

Title:  
AUTOMATIC TRANSMISSION FLUID LEAKModels:  
'00 Celica GTS

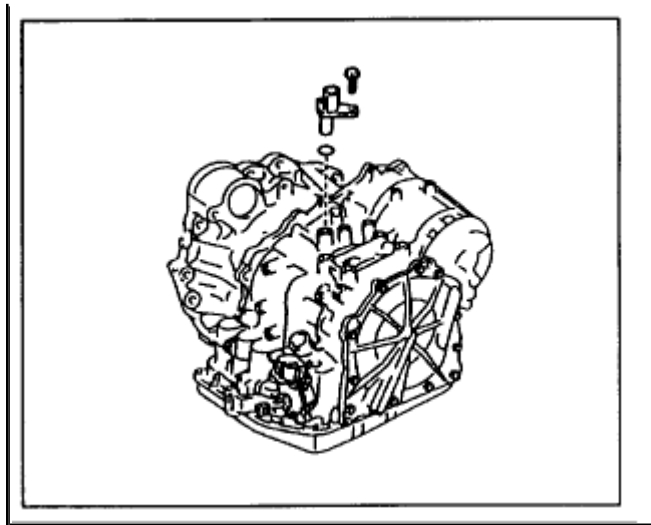
In some cases the U240E transaxle in the 2000 model year Celica GTS may leak automatic transmission fluid from the counter gear speed sensor bolt hole. The repair procedure for this condition is described in this bulletin.

1. Remove the counter gear speed sensor and 'O'-ring.
2. Clean the surfaces of the retaining bolt and the bolt hole.

- A. Blow compressed air into the bolt hole to remove automatic transmission fluid.
  - B. Clean the bolt hole by using a spray cleaner (brake cleaner, etc.) into the hole.
  - C. Clean the bolt threads with a wire brush, then use a spray cleaner to remove debris.
  - D. Repeat the above steps (A through C) 2 to 3 times.
3. Install the speed sensor.
