Roof Side Weatherstrip - Revised Installation

BO022-00

Title: ROOF SIDE RAIL WEATHERSTRIP POOR RETENTION

Models: '00 Celica

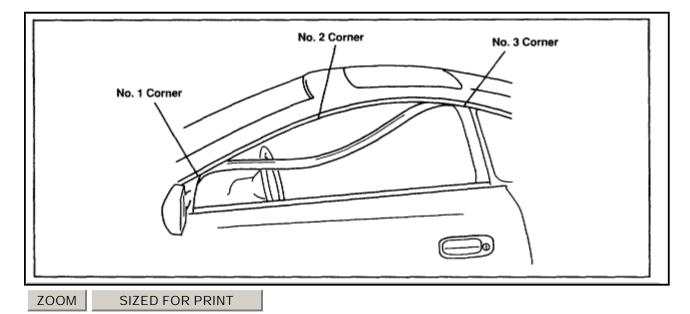
The installation method of the roof side rail weatherstrip has been modified to improve retention between the No. 1 and No. 3 corners on 2000 model year Celica vehicles. The part has not been changed. Use the following installation instructions to reinstall the roof side rail weatherstrip on vehicles with the above concern.
