Tachometer/Speedometer Needle Fluctuation

EL008-99

November 19, 1999

'00 Celica

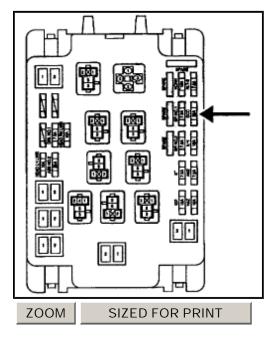
If a vehicle exhibits this condition, check that the DCC 25 amp fuse is in the Junction Block as shown.

The DCC 25 Amp fuse is stored in the Engine Room Junction Block in the engine compartment. Refer to TSB PG027-99 for Celica Fuse Installation During POS.
