Moon Roof - Creak Noise

NV008-01

MOON ROOF CREAK NOISE

'00 Celica

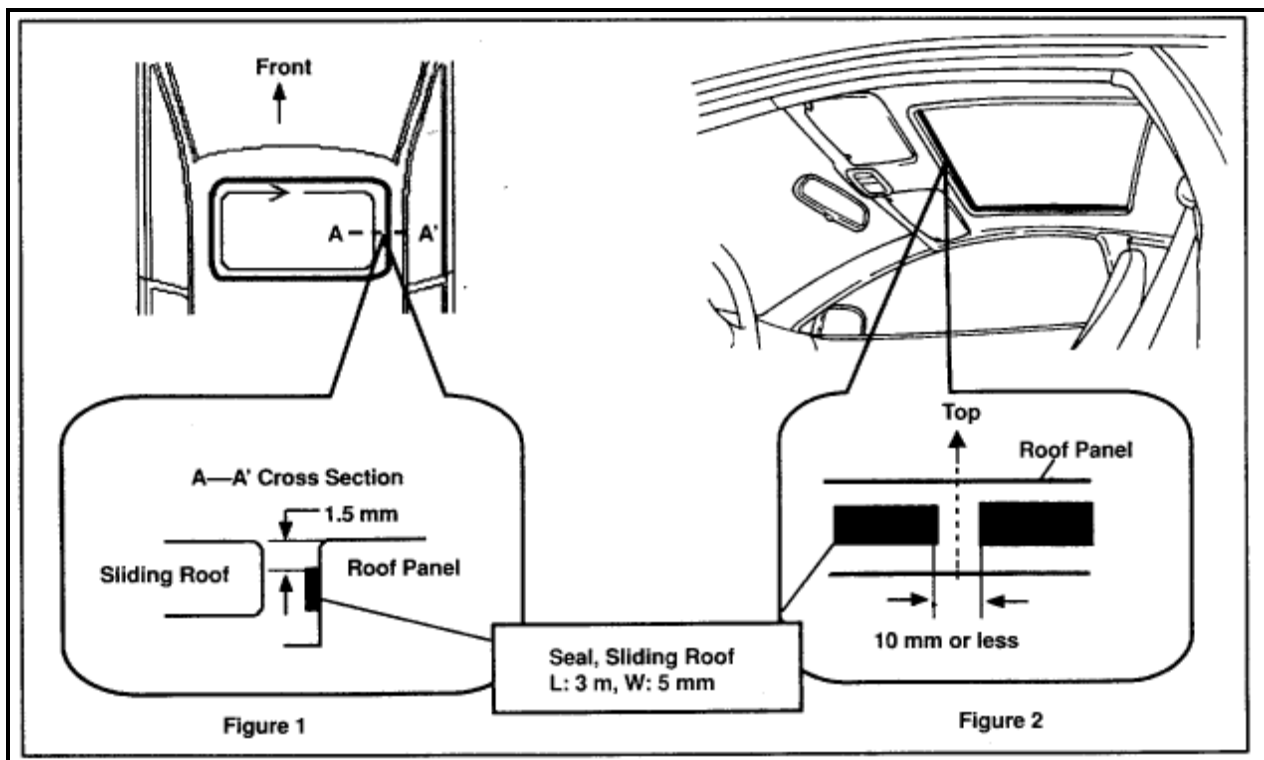
The following procedure is required to correct moon roof creak noise. This condition is caused by dirt or dust between the moon roof seal and the moon roof opening in the roof causing friction.

1. Use alcohol to clean the inside surface of the roof [body](#) flange where the [Sliding Roof](#) Seal is to be applied.
2. Apply [Sliding Roof](#) Seal to the inside surface of the roof panel as follows:

Applying position of the Seal to roof panel top surface - 1.5 mm (See Figure 1).

- a. Keep the [Sliding Roof](#) Seal lightly stretched when applying it.

Do not, however, stretch the [Sliding Roof](#) Seal when applying it to the corner of the roof panel.

- b. Cut the [Sliding Roof](#) Seal so that the gap will be 10 mm or less and the ends may not overlap (See Figure 2).
- c. Press the [Sliding Roof](#) Seal to let the air out of it.
3. Clean the outside of the moon roof weatherstrip.
