SUNSHADE TRIM REPLACEMENT

BO007-00

'00 MY Celica

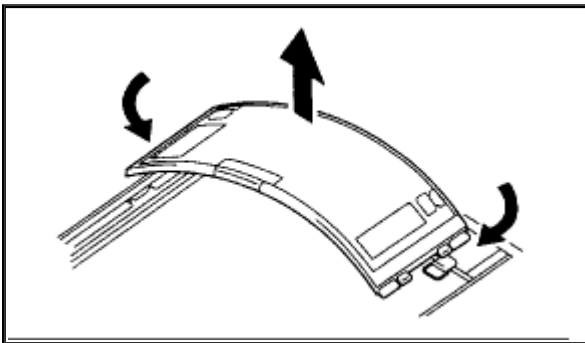
A. Release the spring between the No.1 and No.2 sunshades on both sides.

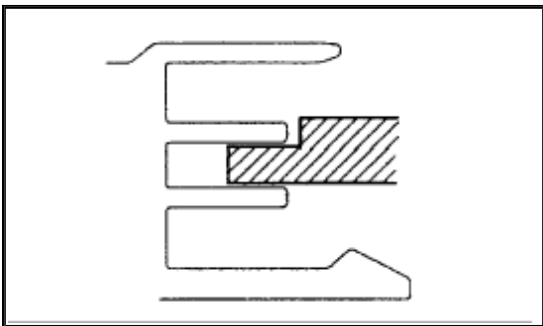
B. Bend the No.1 sunshade in the center to remove it as shown.

C. Repeat the same procedure for the No.2 sunshade.

NOTE: Bending the sunshade excessively may cause damage.

HINT: When re-installing the sunshade, insert it into the slider rail as shown.
