Daytime Running Light - Disabling Procedure

EL011-00

DAYTIME RUNNING LIGHT DISABLING PROCEDURE

All Models

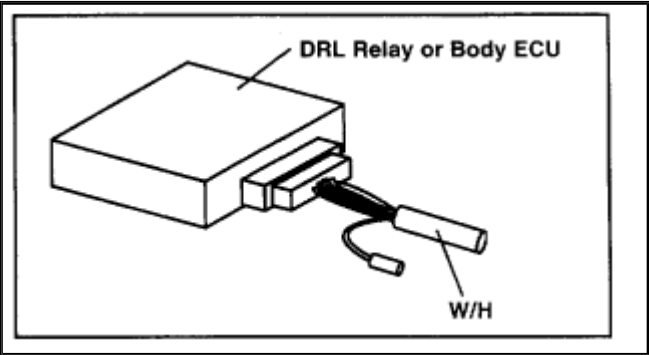
- 1. Disconnect the Battery.

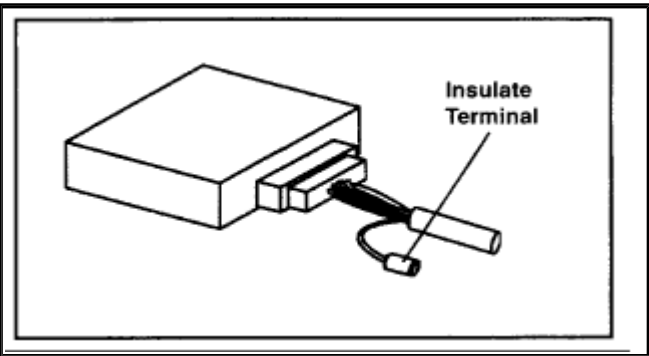
- 2. Use the locking pick tool from the wire harness repair kit and back out the terminal from the appropriate connector for the DRL Relay or Body ECU. See the Reference Chart as shown in this bulletin for pin and connector information.

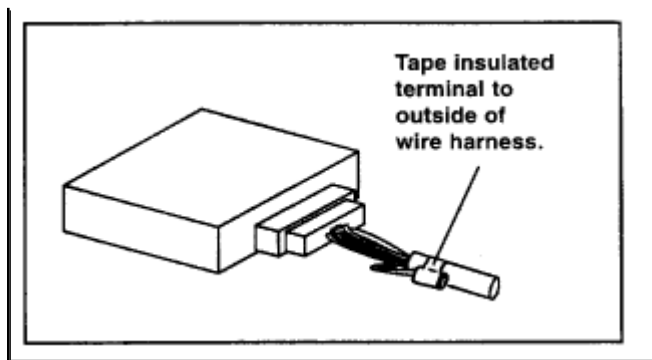
- 3. Insulate the removed terminal using vinyl electrical tape.

4. Secure the wire and terminal to the outside of the wire harness using vinyl electrical tape.

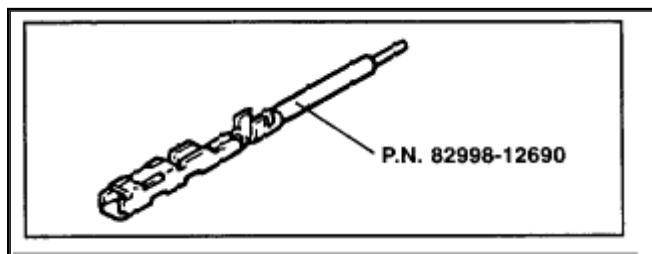
5. For 2000 model year Avalon:

A. Order a new terminal with lead that is the same size and type as the terminal previously removed from the connector. (PN 82998-12690)

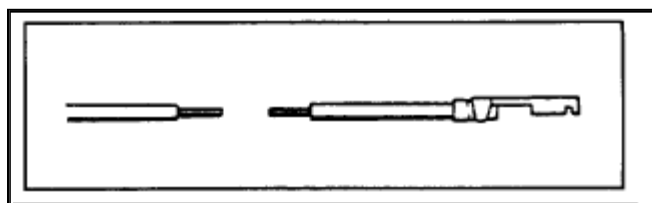
B. Securely attach a 45 cm/ 18 in wire with an outside diameter of 2.0 mm or larger to the tail of the new terminal.

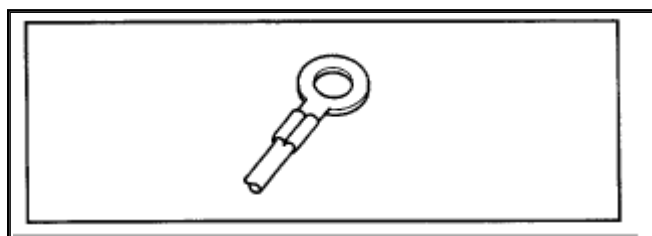
C. Securely attach an eyelet with a hole size of 7 mm to the end of the new wire.

D. Insert the new terminal with lead into the Body ECU Connector B5, previously vacated by the original terminal.

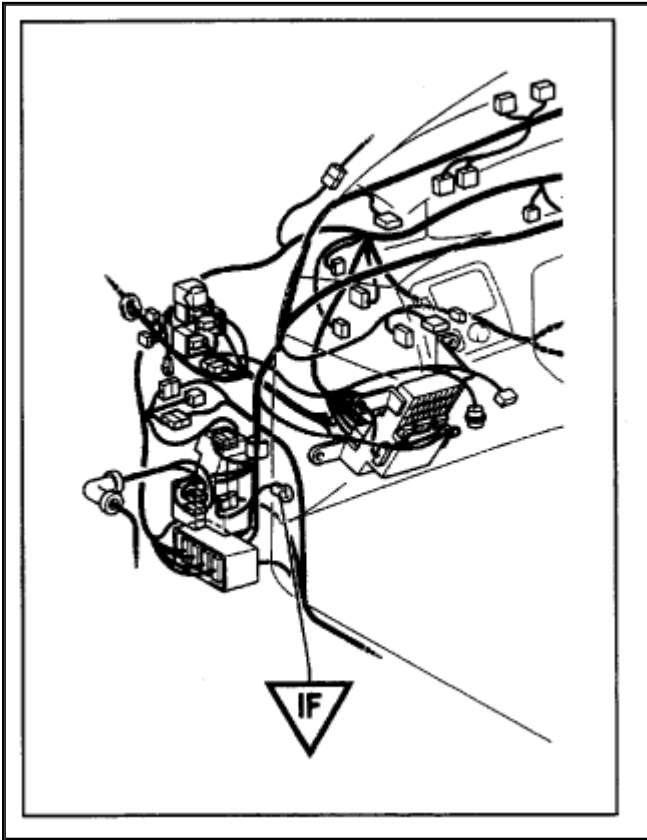
- E. Properly attach and route the new wire to the exterior of the existing wire harness in a manner that will not allow it to become damaged or come into contact with any other circuits.
- F. Securely attach the eyelet to the existing ground point located in the left kick panel area. (Ground Point IF)
- 6. Check that the Daytime Running Light (DRL) operation has been disabled.
- 7. Reassemble any interior panels that were removed to gain access to components, connectors, etc.
